San Jacinto River Waste Pits Superfund Site

Temporary Cap Construction Completed July 2011

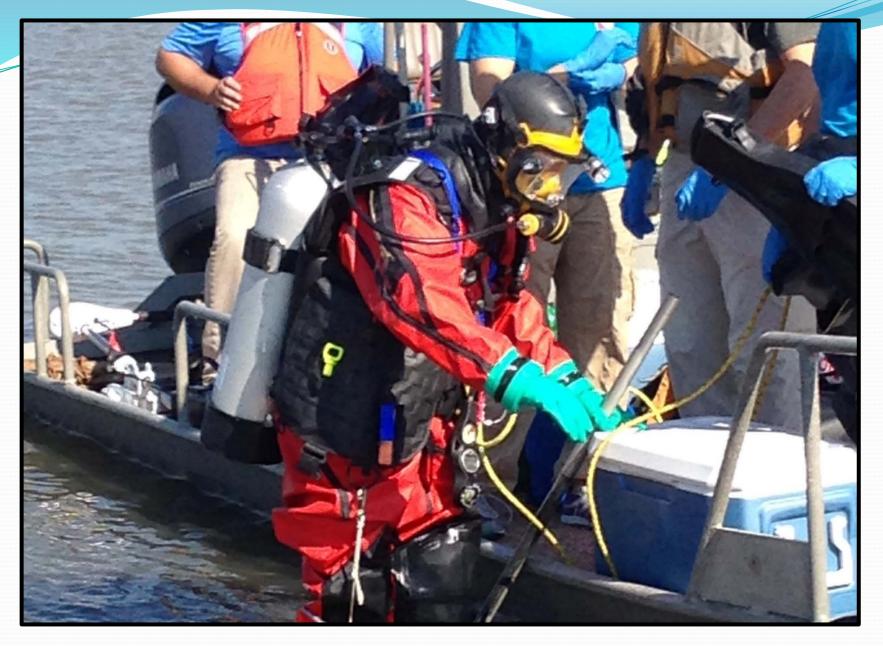
Overview of Damaged Area

- Prior to repair paper mill waste containing dioxin was exposed to environment.
- Cause of damage unknown & under investigation.
- Cap repairs completed Jan 4.
- Site is securely fenced & access prohibited.
- Quality assured data confirmed surrounding cap areas remain protected.

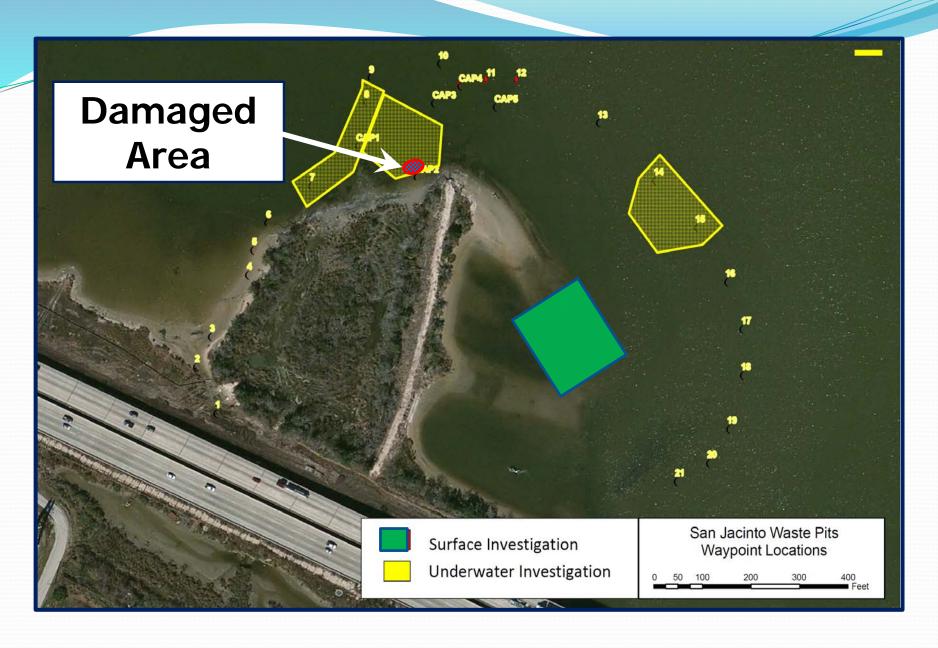
EPA Dive Team inspection - Dec 2015

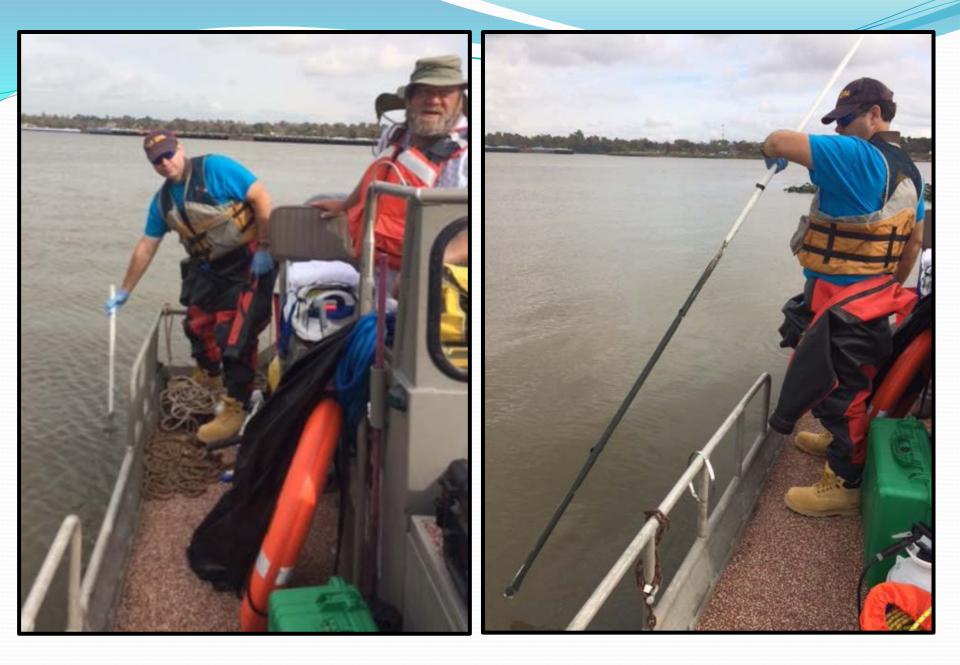
Areas investigated by EPA Dive Team

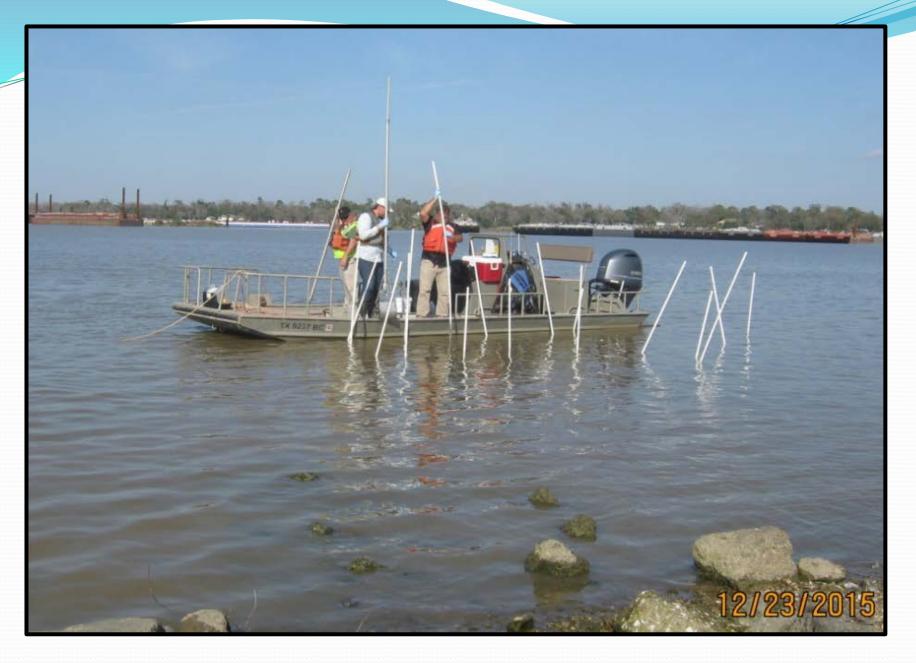
Dive Team inspection Results

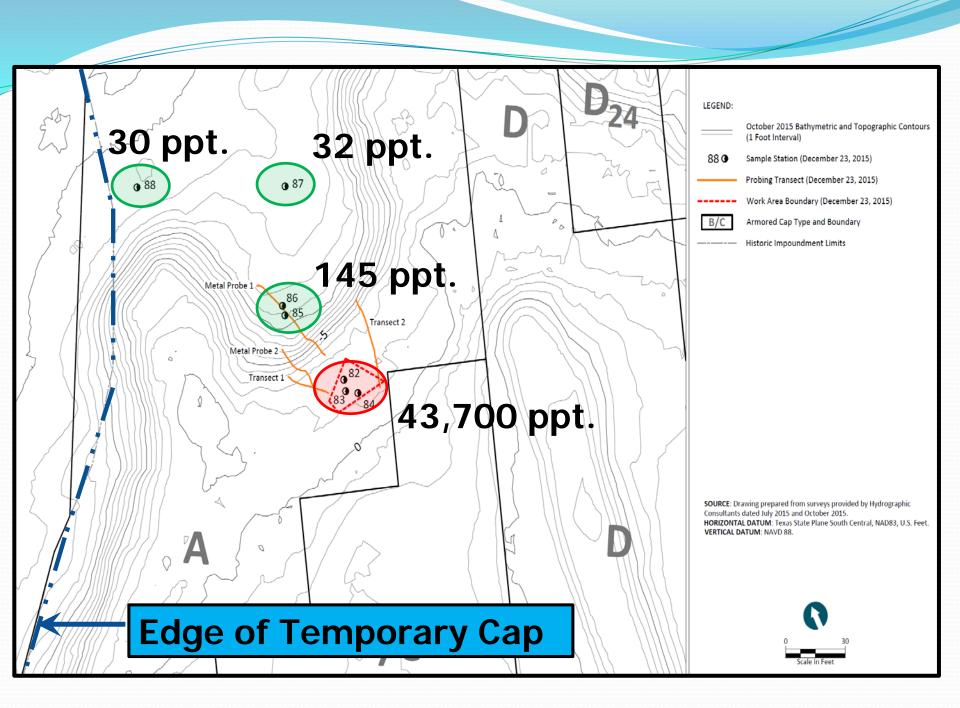
Probing to define damaged rock area

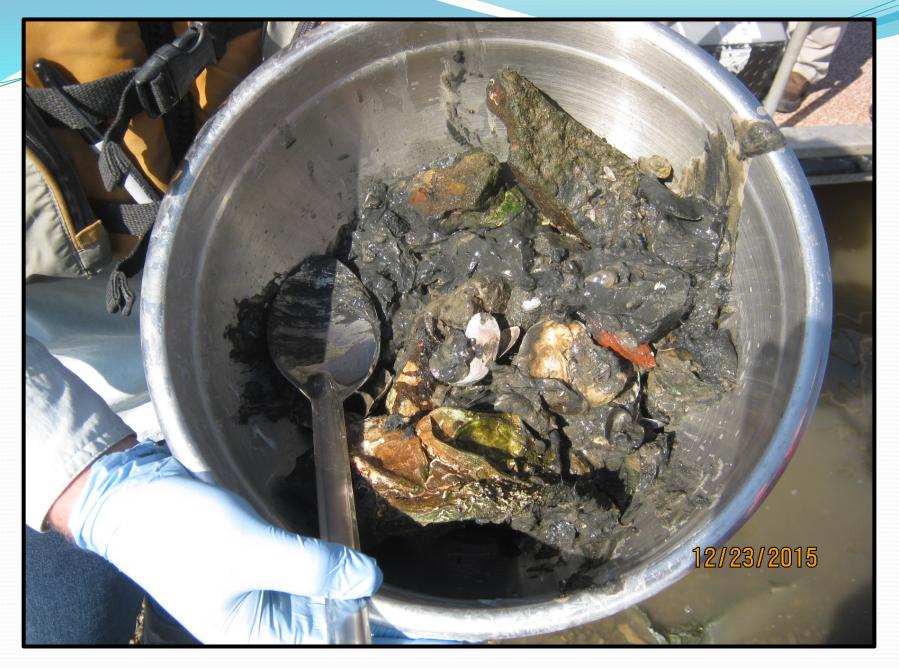
Shallow sample from damaged cap.
